Manhole Inspection Summary

Manhole # S15II1035MH

Insp Date: **12/13/06 1:14 PM**

Location Address: **2511 LOYOLA NORTHWAY**

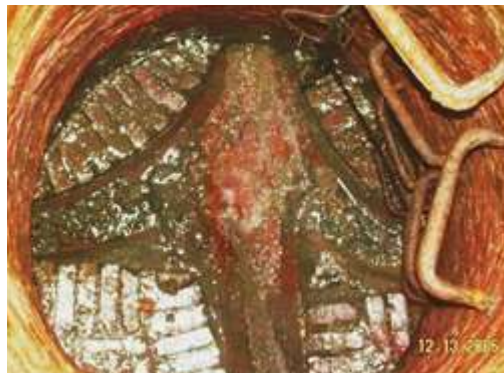
Top View

Corroded steps. Bench debris.

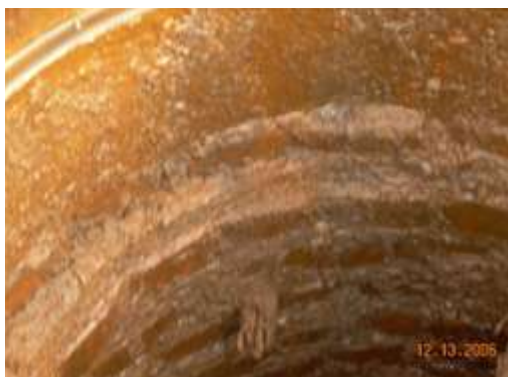
Defect

Frame leaks. Adjustment infiltration.
Missing step.

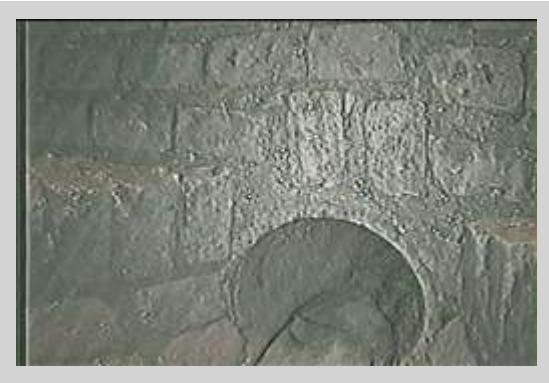
8 in. Circular Gravity Sewer Pipe Out @ 12 O'Clock

Deposits: ☐ None ☐ Mud ☐ Sludge ☒ **Debris** ☐ Grease

Silt Depth: **1** (in.) Deposits Extent: **Light**

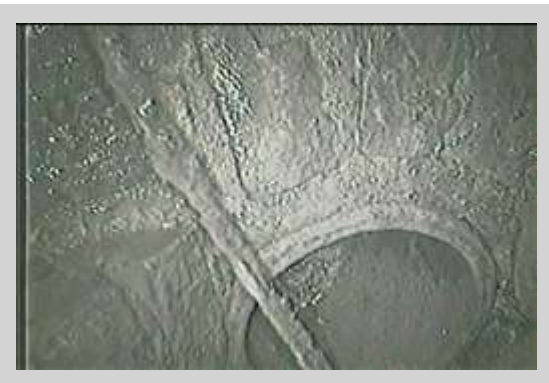
6 in. Circular Gravity Sewer Pipe In @ 4 O'Clock

Deposits: ☐ None ☐ Mud ☐ Sludge ☒ **Debris** ☐ Grease

Silt Depth: **0.5** (in.) Deposits Extent: **Light**

Infiltration: **None** Pipe Seal Cond: **Cracked**

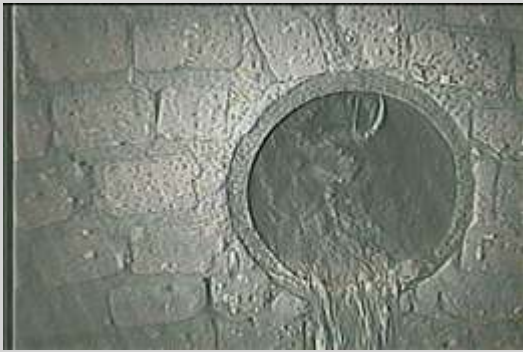
Pipe In @ 6 O'Clock

Infiltration: **Evidence** Pipe Seal Cond: **Unknown**

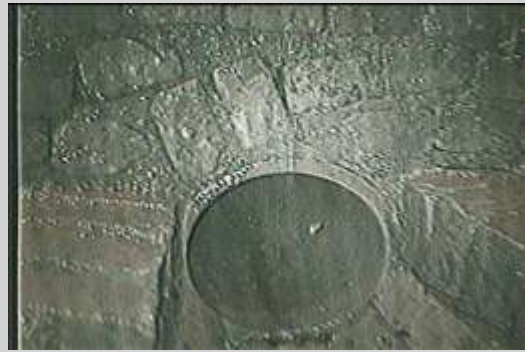
Drop In @ 6 O'Clock

Drop Condition: **Clogged**

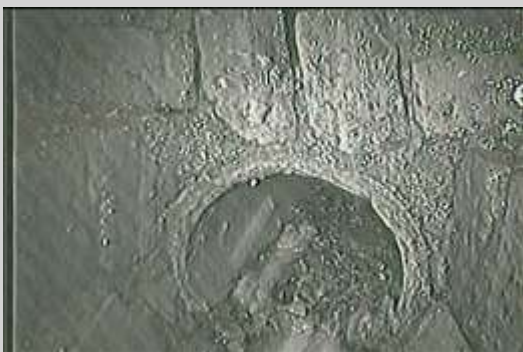
Pipe In @ 8 O'Clock

Deposits: ☐ None ☐ Mud ☐ Sludge ☒ **Debris** ☐ Grease

Silt Depth: **1** (in.) Deposits Extent: **Light**
